Manhole Inspection Summary

Manhole # S37AA_016MH

Location Address: **920 forrest st**

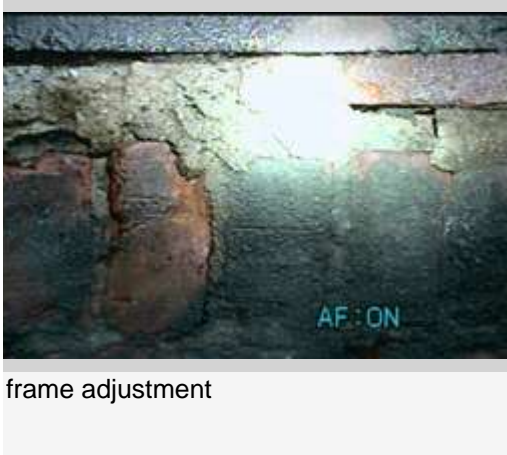
Misc

frame adjustment

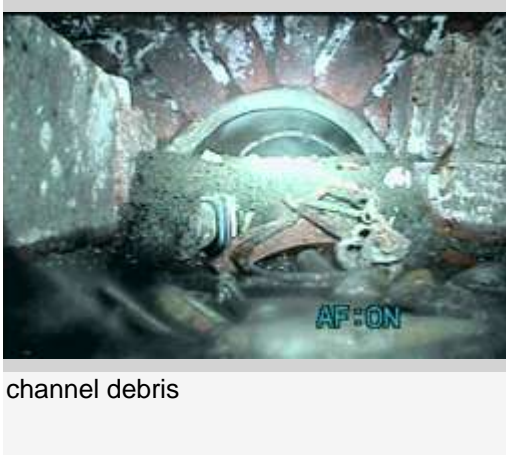
Defect 3

Condition: ☐ Sound ☐ Cracked ☐ Root Intrusion ☐ Deteriorated ☐ Leaks ☒ **Debris**

channel debris

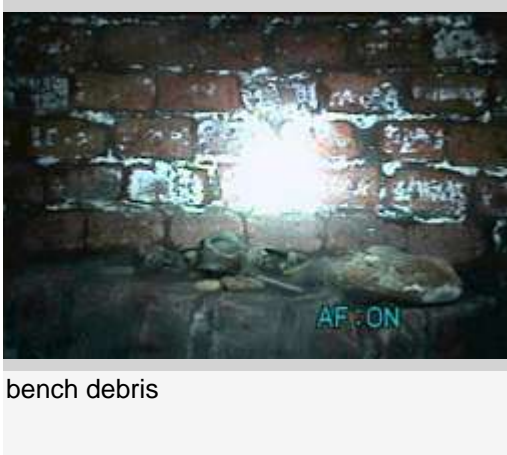
Defect 2

Condition: ☐ Sound ☐ Cracked ☐ Root Intrusion ☐ Deteriorated ☐ Leaks ☒ **Debris**

bench debris

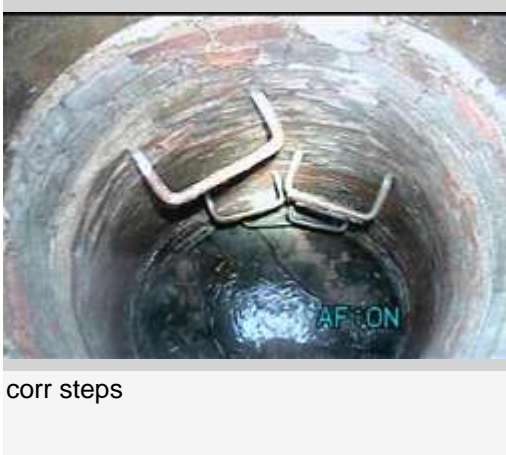
Defect 1

Count: **5** Missing: **0** ☒ **Corroded**

corr steps

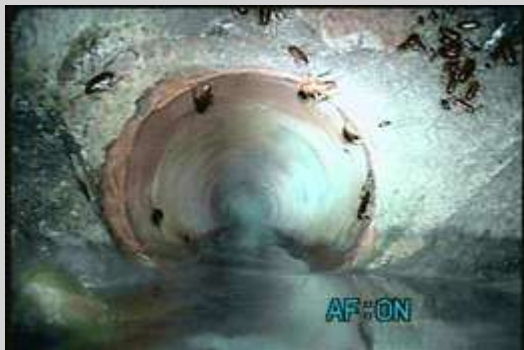
12 O'Clock Outflow

8 in. Circular Gravity Sewer
Pipe Out @ 12 O'Clock

Invert Depth: **9.83** (ft.) Flow Characteristics: **Fast**

Infiltration: **None** Pipe Seal Cond: **Unknown**

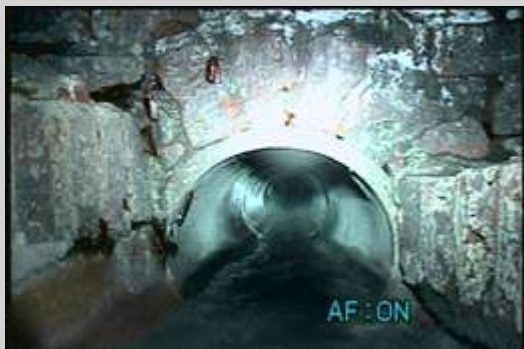
4 O'Clock Inflow

8 in. Circular Gravity Sewer
Pipe In @ 4 O'Clock

Invert Depth: **9.79** (ft.) Flow Characteristics: **Fast**

Infiltration: **None** Pipe Seal Cond: **Unknown**

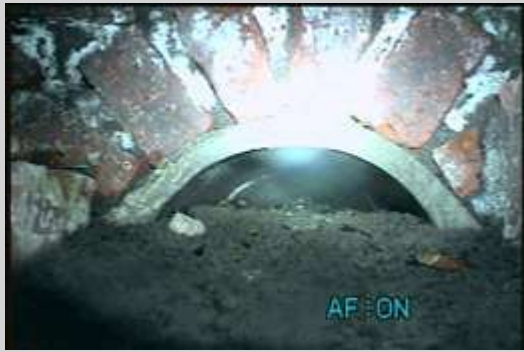
7 O'Clock Inflow

Pipe In @ 7 O'Clock

Invert Depth: **9.66** (ft.) Flow Characteristics: **None**

Connects To: **Dead End**

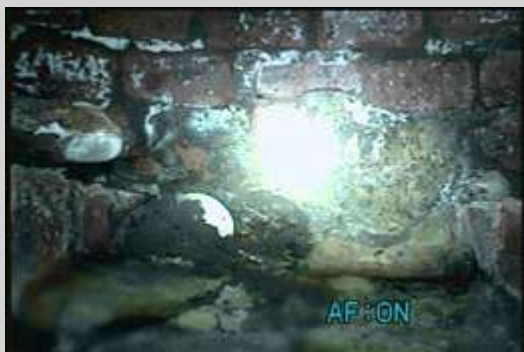
10 O'Clock Inflow

lots of debris looks sealed up

Invert Depth: **9.46** (ft.) Flow Characteristics: **None**
